## CITY OF COEUR D'ALENE

## Urban Forestry Committee Draft Minutes Friday, November 21<sup>st</sup>, 2025 – 8:05am City Hall – Conference Room 6

# Tree Assessment Report – Grandmill Townhomes HOA

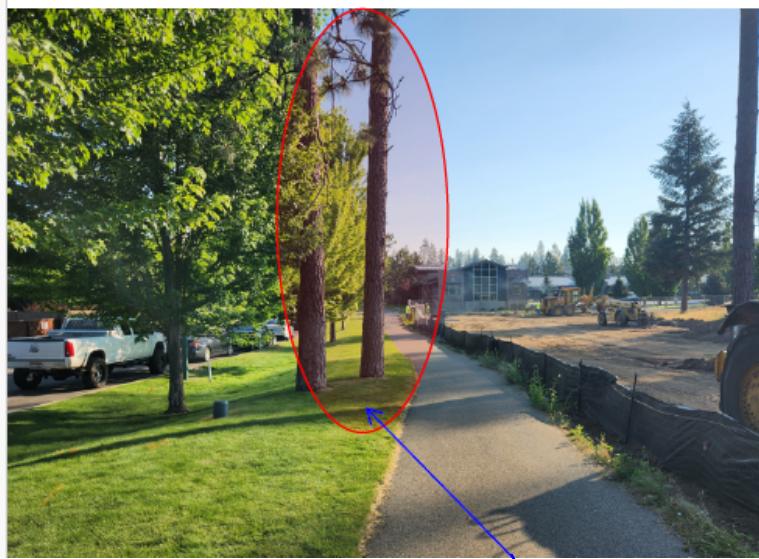
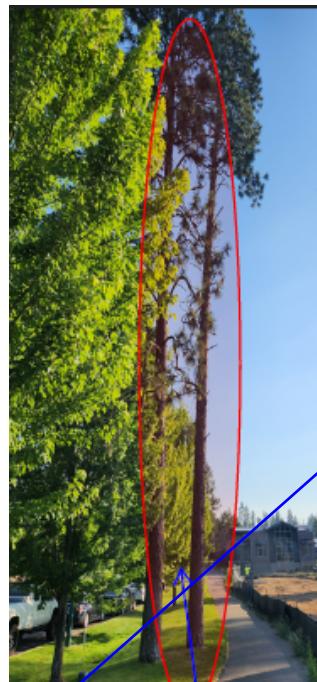
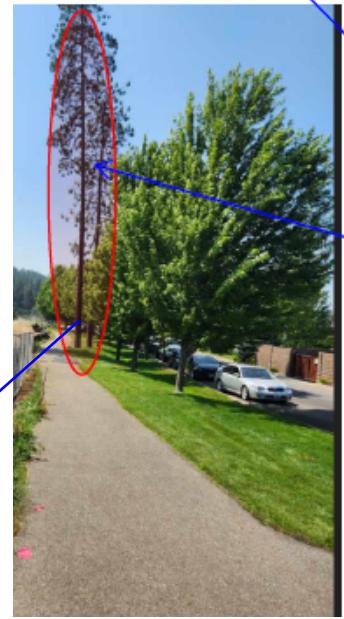
Two trees referenced  
in this request.

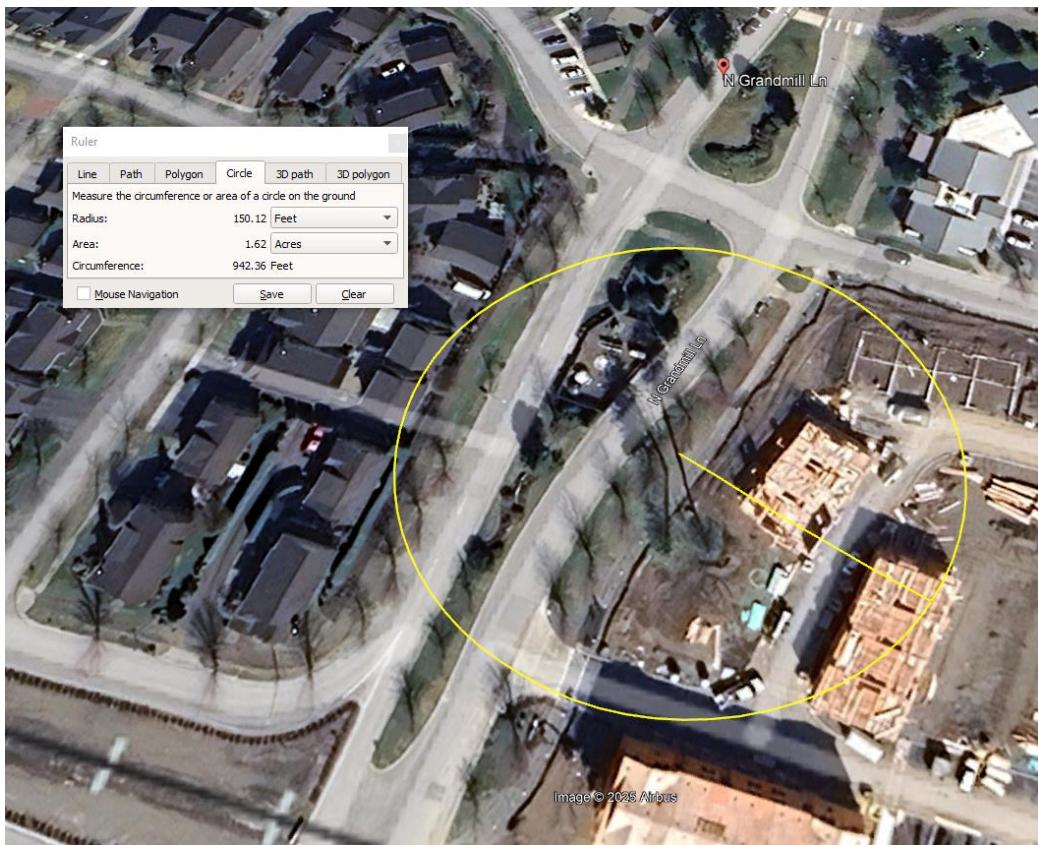
Pedestrian and vehicle traffic along Grandmill Ln present potential targets, with occupancy rates varying from occasional to frequent, but the primary targets of concern are the buildings and parking lot of the new townhomes being constructed, and the future occupants. Once finished, they are expected to have constant occupancy, and are located completely within the target zone of 1x the tree height. (Figure 1)

Figure 1- Target zone of 1x the height of tree #1, the tallest of the two trees.

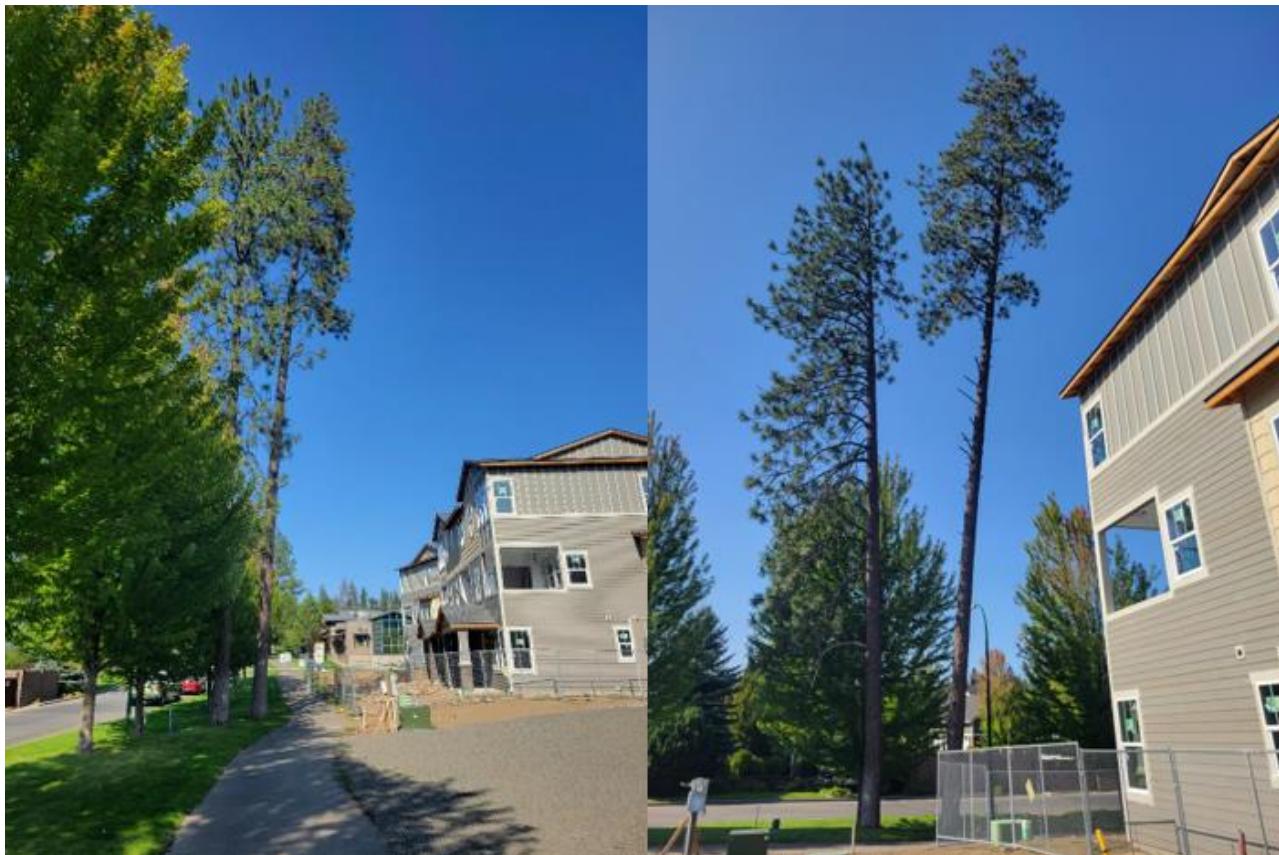
Lean- Both trees exhibit slight lean. Tree #1 is estimated to have approximately 5° of lean in a slightly ESE direction, while tree #2 is estimated to lean approximately 2.5° to the East. No obvious root heaving or soil disturbance is visible as a result of the lean but note comments on lack of trunk flare below. (Figure 2)

Figure 2- Angle of lean viewed from the South (left) and the East (right). Also note the lower proportions of canopy size vs height.

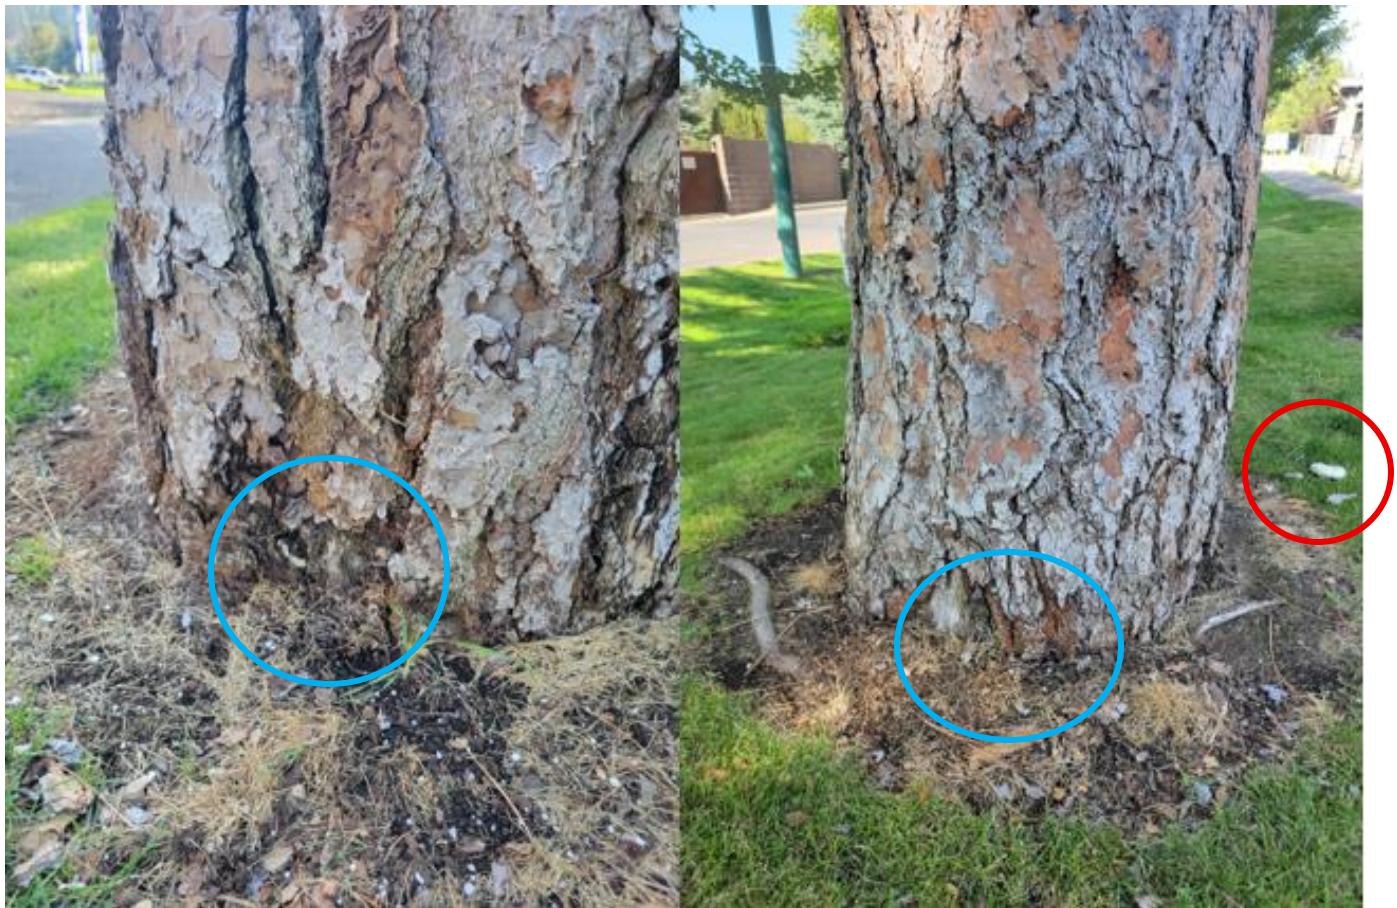
Mower Damage- Both trees show some signs of mower damage at the base, but being thick-barked trees, this damage appears minimal with small areas of exposed wood visible at the base of both trees.

Root Zone/Trunk Taper- Both trees are in a turf swale that is irrigated multiple times per week, and mushroom fruiting bodies were visible in the grass around the base of tree #2 at the time of inspection. It is possible that the mushrooms originate from the roots of one of the maple trees also present in the swale, or from other buried woody debris decomposing, though no mushrooms were found elsewhere in the swale to support this. The mushrooms may be a sign of root rot in one or both trees. Ponderosa pines typically have minimal trunk taper, but even compared to other ponderosas, both trees have poor taper as well as no visible root collar/flare. Ponderosa pines tend to prefer somewhat drier soil conditions, but the swale had new sod installed this year, and the soil is perpetually saturated to maintain the turf, and may have been raised slightly around the trunks, increasing the potential for future decay. (Figure 3)

Figure 3- Lack of trunk flare on tree #1 (left) and tree #2 (right). Mower damage also visible on both trees (circled in blue), and mushrooms near the base of tree #2 (circled in red).

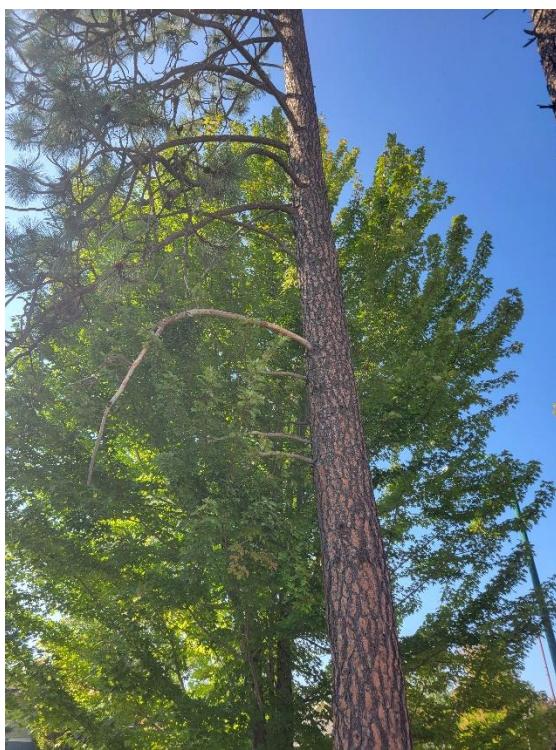
Canopy Thinning/Dieback- Both trees exhibit dieback of the lower branches, with many stubs visible on tree #1 from old branch failures, and visible stubs plus several dead branches on tree #2. Tree #1 has approximately 30% canopy to height ratio, and tree #2 about 50%. Most of the remaining branches on tree #2 are concentrated on the

SSW side of the tree, leading to an unbalanced canopy and uneven loading, which would be particularly pronounced during high wind events. The attached dead branches on tree #2 present a falling hazard that may impact vehicle or pedestrian traffic with potentially significant consequences, resulting in a moderate risk rating. (Figure 4)

Figure 4- Attached dead branches visible on tree #2, of varying age.

If removal is not planned, continued re-assessment of these trees on an annual basis is a must. Continue to measure lean and to monitor trunk flare and canopy density as indicators of overall vigor. Maintenance must support overall tree health and promote the tree’s natural ability to structurally compensate for the existing lean. Recommended maintenance changes include a reduction in irrigation frequency and amount, the addition of tree rings to exclude grass against the trunks and prevent mower and trimmer damage, and supplemental fertilizer to promote healthy root growth and to introduce beneficial microbes. Root collar excavation is also highly recommended to expose any existing root collar area and reduce the likelihood of decay. Specifically relating to the hazard of dead branches on tree #2, mitigation by pruning out the dead branches would immediately reduce the risk related to falling branches and is highly recommended if whole tree removal is not planned in the immediate future.
